**Henderson Wood  
Property Services**

# Example Residential Damp Survey

# Residential Damp Survey Report

| Property Address | EXAMPLE ADDRESS |

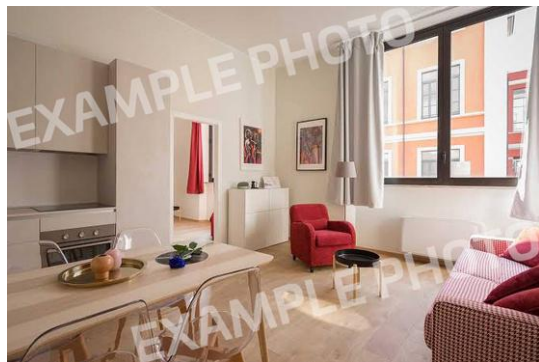
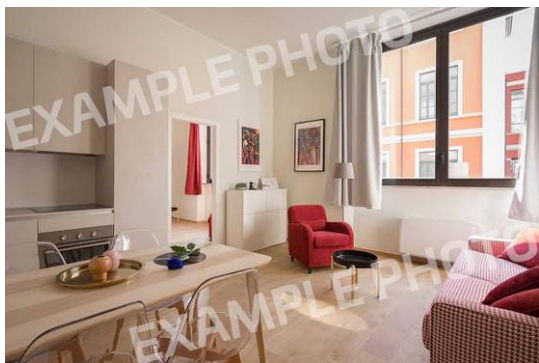
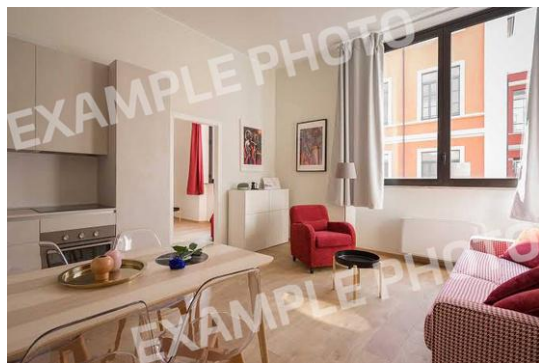
Single-storey rear kitchen extension and a shared party wall to both neighbouring terraces. Garden boundary walls abut the rear elevation.

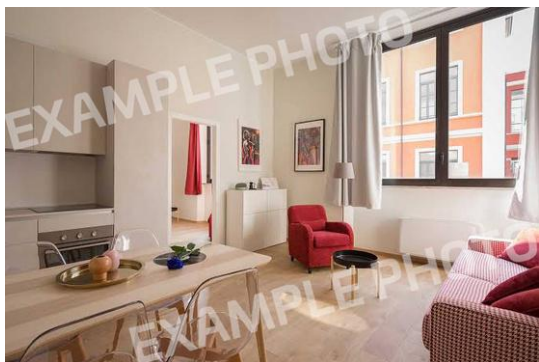
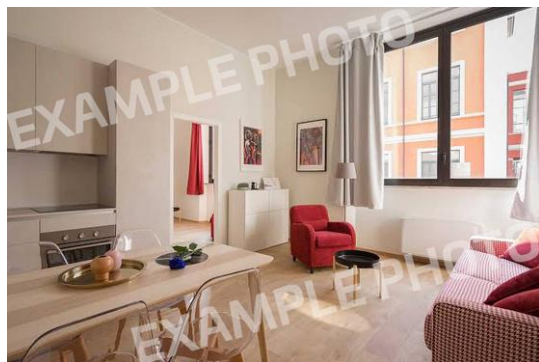
Rear patio falls back toward the building rather than away from it, directing surface water to the base of the rear wall.

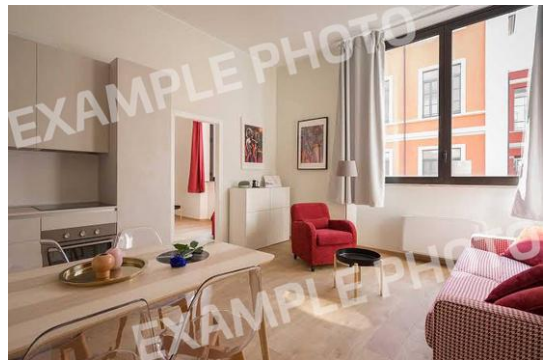
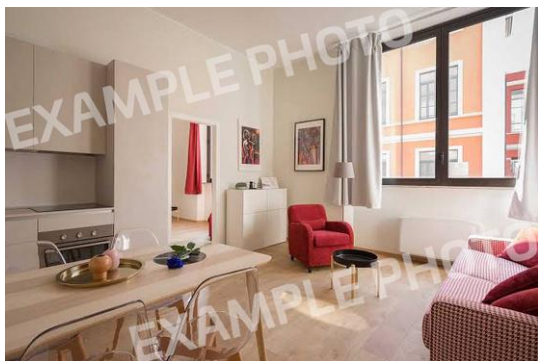
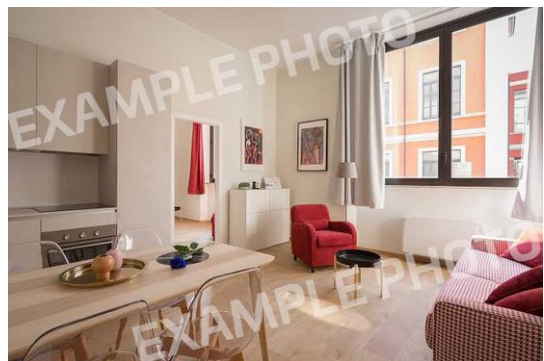
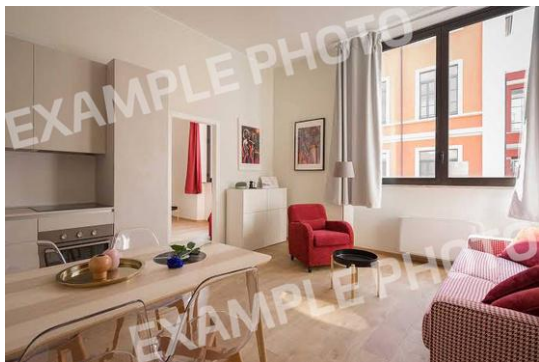
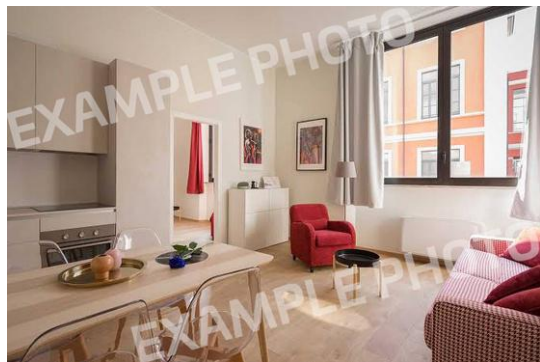
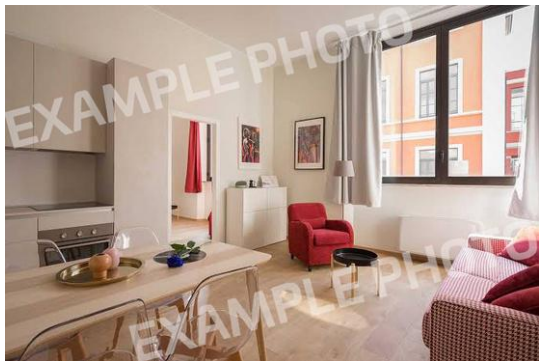
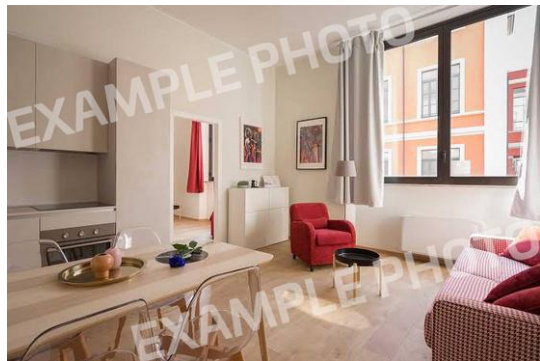
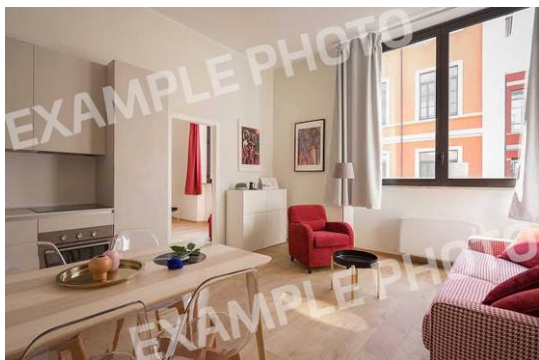
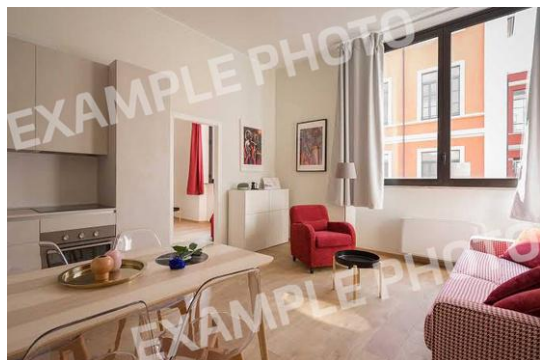
Front reception room

Rising damp

Bridged and locally defective damp proof course. Raised external ground level and cement render spanning the DPC are allowing ground moisture to migrate into the wall base. Elevated moisture readings and hygroscopic salt banding (tide mark) consistent with rising dampness. Skirting board soft to probe at low level.

Perished pointing, external ground levels

High - action required within 14 days

Reduce external ground levels below the DPC where practicable and remove render bridging. Install a replacement chemical DPC using Safeguard Europe Dryzone Damp-Proofing Cream in accordance with BBA Certificate 97/3363 and BS 6576:2005. Hack off salt-contaminated plaster to 1m and re-plaster using a Safeguard Drybase system. Replace decayed skirting.

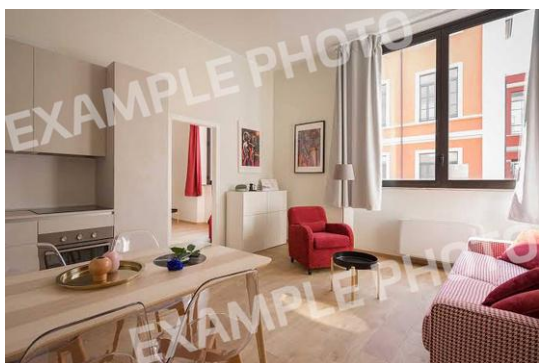
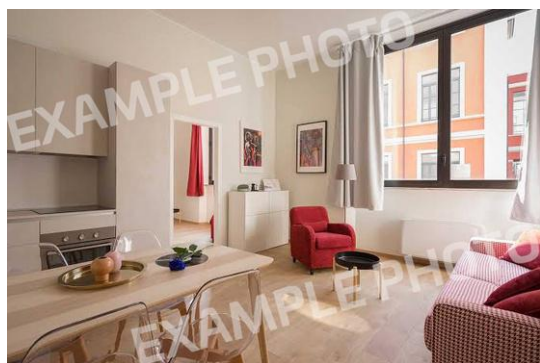
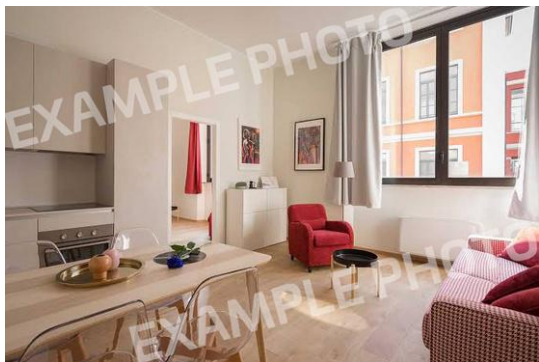
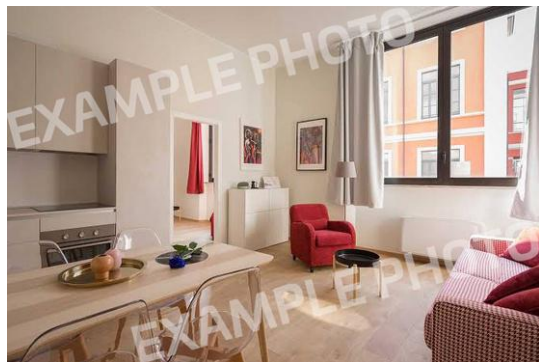
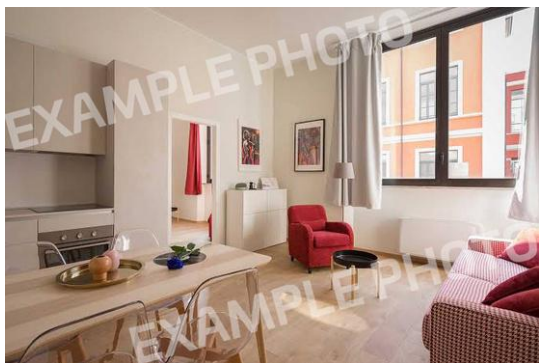
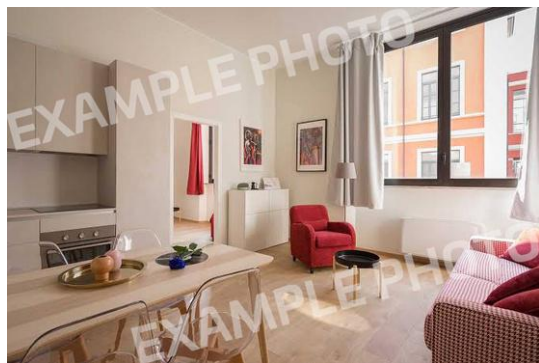
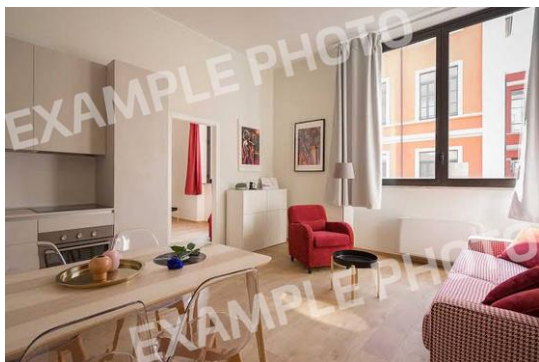
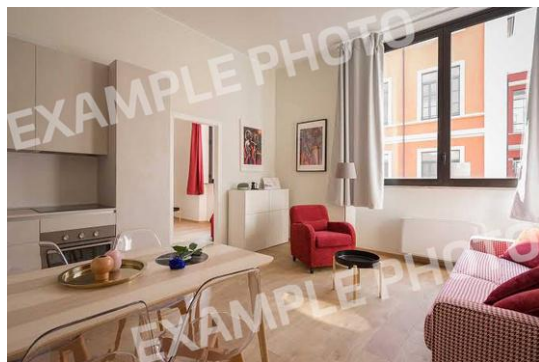
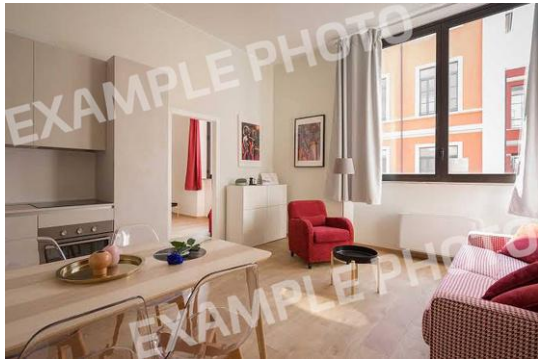
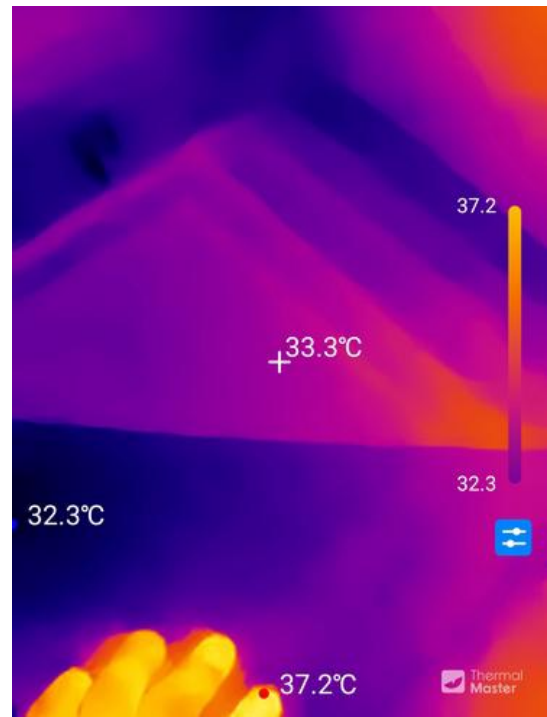
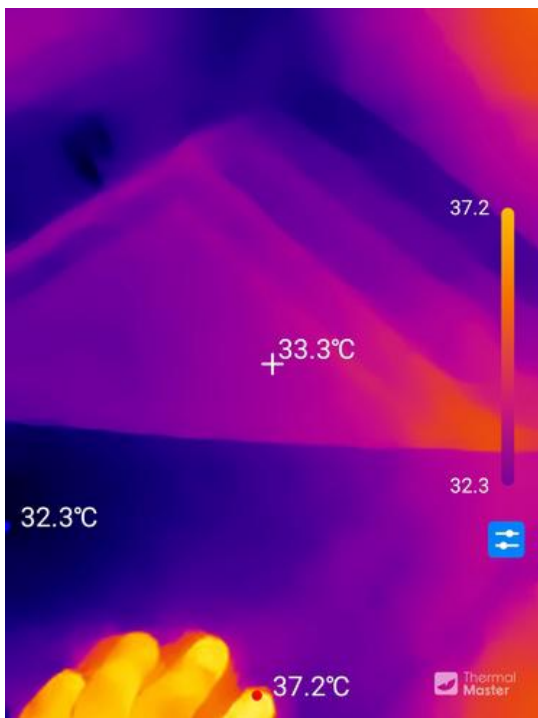
Rear kitchen

Penetrating damp

Water ingress from the defective rear gutter and displaced downpipe saturating the external wall, showing internally as damp staining and localised surface deterioration to the plaster. Thermal imaging was used to confirm and map the extent of the affected area. The thermogram showed a distinct cooler zone across the upper rear wall consistent with evaporative cooling from moisture, extending noticeably beyond the visible staining and correlating with elevated protimeter readings taken across the same area.

Defective rainwater goods, blocked gulley

High - action required within 14 days

Overhaul the rear guttering, re-fix the displaced downpipe, and clear the gulley to restore controlled discharge. Once the source is corrected and the wall has dried, apply Stormdry Masonry Protection Cream (BBA Certificate 15/5198) externally and make good internal plaster. Recommend a follow-up thermal and moisture reading once dried to confirm the wall has fully recovered before redecoration.
